THE INSTITUTE OF PAPER SCIENCE AND TECHNOLOGY

Corrosion in Electrostatic Precipitators

Project 2926-9

R E P O R T T W O

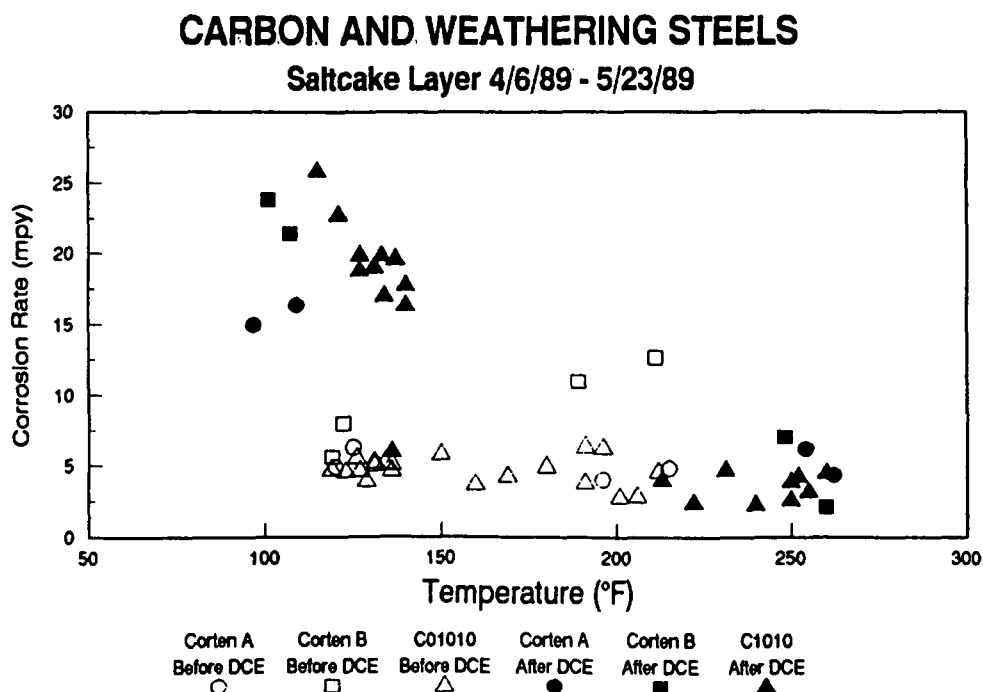
A similar seasonal trend was observed in the two runs conducted with saltcake cover over the coupons. In the run conducted in June-August , the critical temperature became 110 °F for the flue gas before the cascade and 160 °F after it (Fig. 56) whereas in the run performed earlier in the spring such a difference in the critical temperature between the two test locations was not observable (Fig. 54, ca 125 °F for both).

Figure 54. Corrosion data from the Cedar Springs mill with saltcake on the coupons.

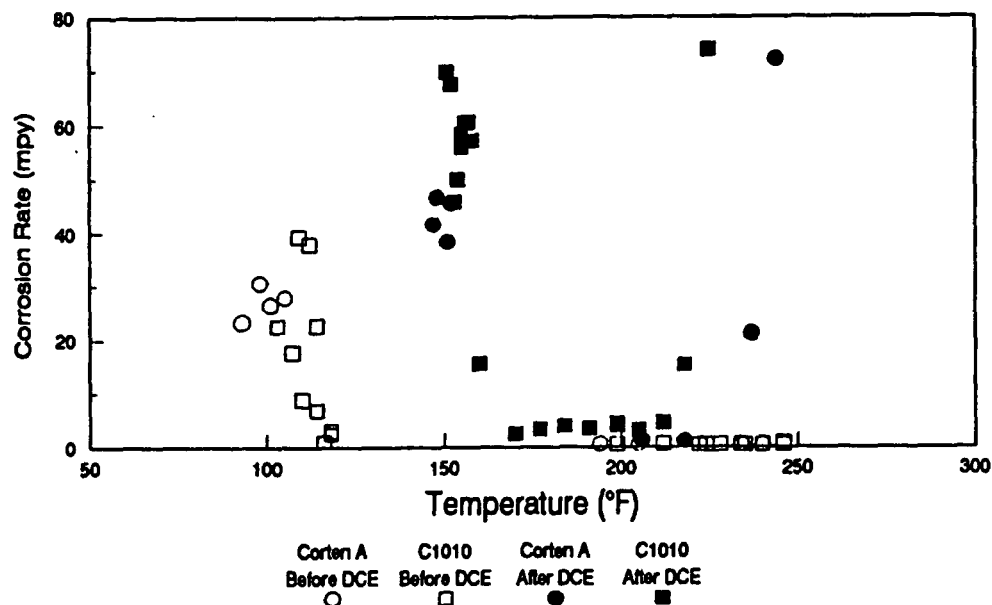
Figure 55. Corrosion data from a test run at the Cedar Springs mill without saltcake on the coupons.

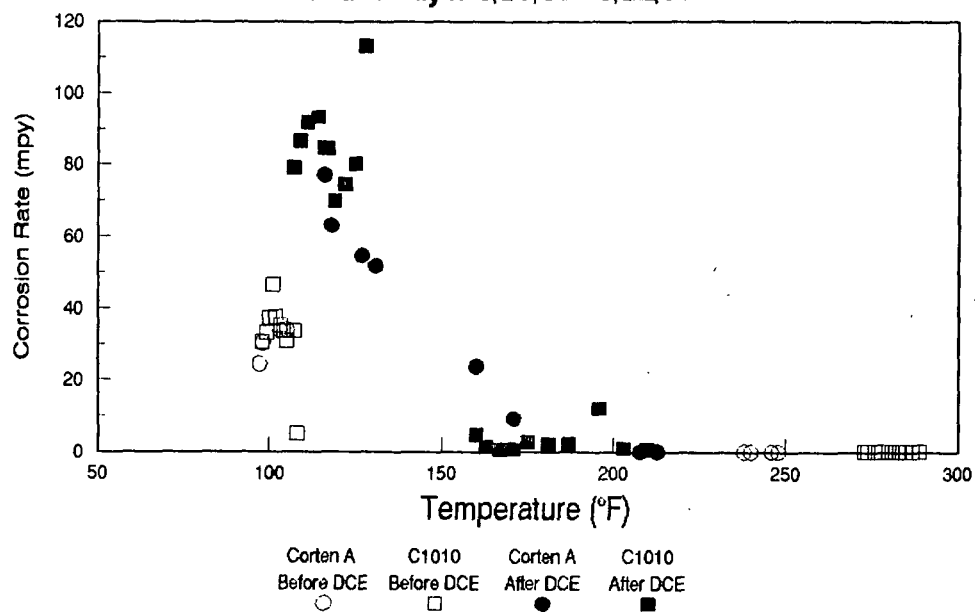
The most severe corrosion impact should take place just below the dew point, when the surface becomes just wetted and the water film is relatively concentrated by corrosive species absorbed from the gaseous phase. At a still lower temperature, more water is condensed and the liquid film on the metal will then be diluted and less aggressive. Thus, a relatively narrow temperature range for high corrosion rate should be seen below the dew point. Unfortunately, it was not possible in each run to cover the temperature range of the most interest with evenly distributed data points in order to trace point for point the effect of the temperature below the dew point. Some of the plots obtained in this work indicate of the existence of such a maximum, e.g., Fig. 56.

Figure 56. Corrosion data from the Cedar Springs mill with saltcake on the coupons.
